**REPORT OF THE INVESTIGATION
INTO THE
EVER FORWARD (O.N. 9850551) GROUNDING
IN THE VICINITY OF CRAIGHILL CHANNEL
ON MARCH 13, 2022**

MISLE ACTIVITY NUMBER: 7412263

**THE GROUNDING OF THE FOREIGN CONTAINER VESSEL EVER FORWARD
(IMO 9850551) IN CRAIGHILL CHANNEL EAST OF BUOY 16 NEAR
BALTIMORE, MD ON MARCH 13, 2022**

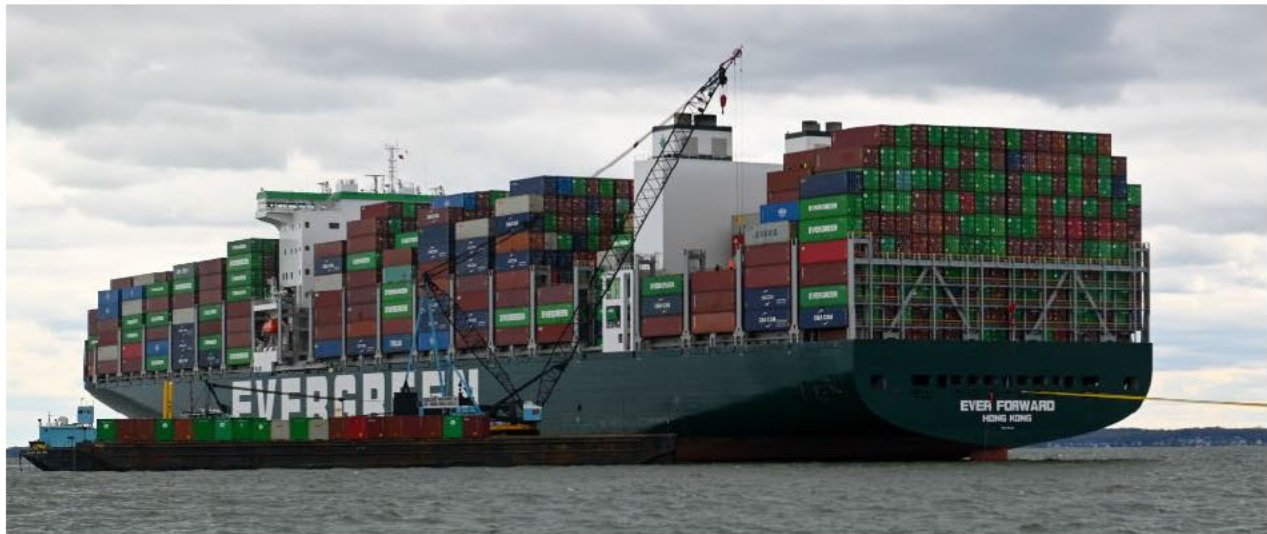
Figure 1. View from the port quarter of EVER FORWARD, aground east of the Craighill Channel.
 Photograph taken April 14, 2022 by USCG.

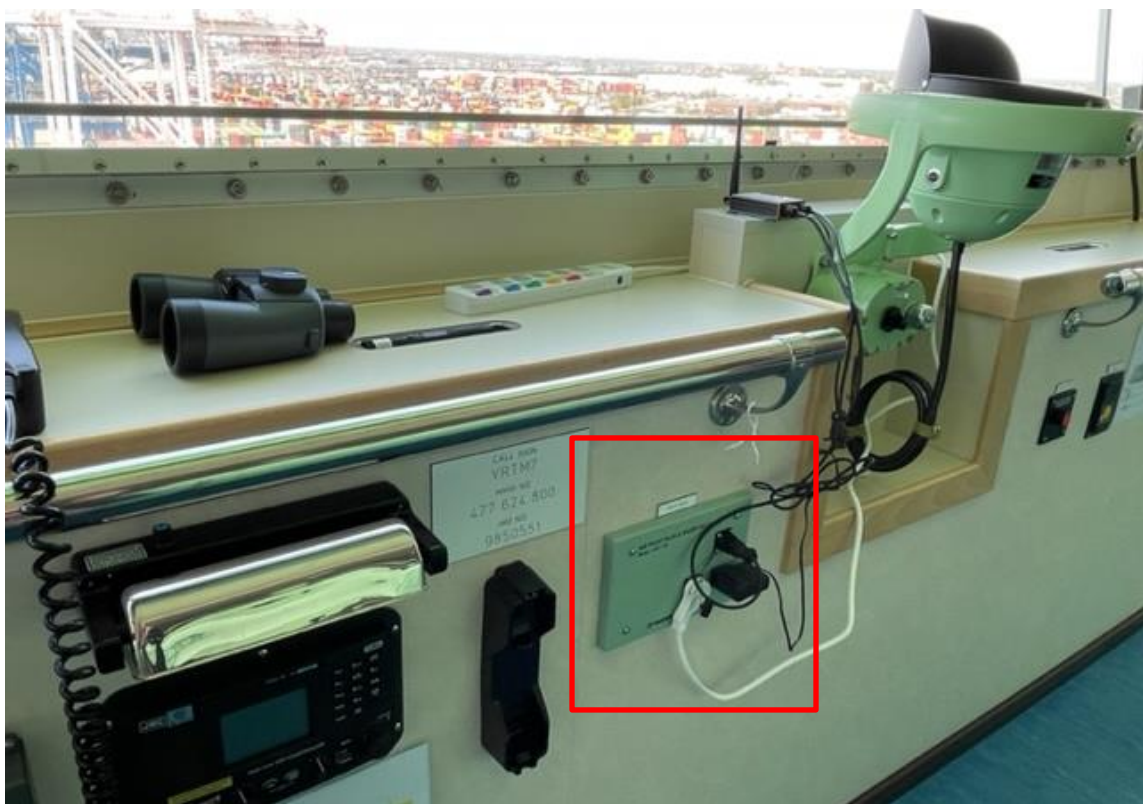
Figure 2. The red square shows the location of EVER FORWARD’s Pilot Plug. This photograph was provided by Association of Maryland Pilots and taken in Baltimore, Maryland.

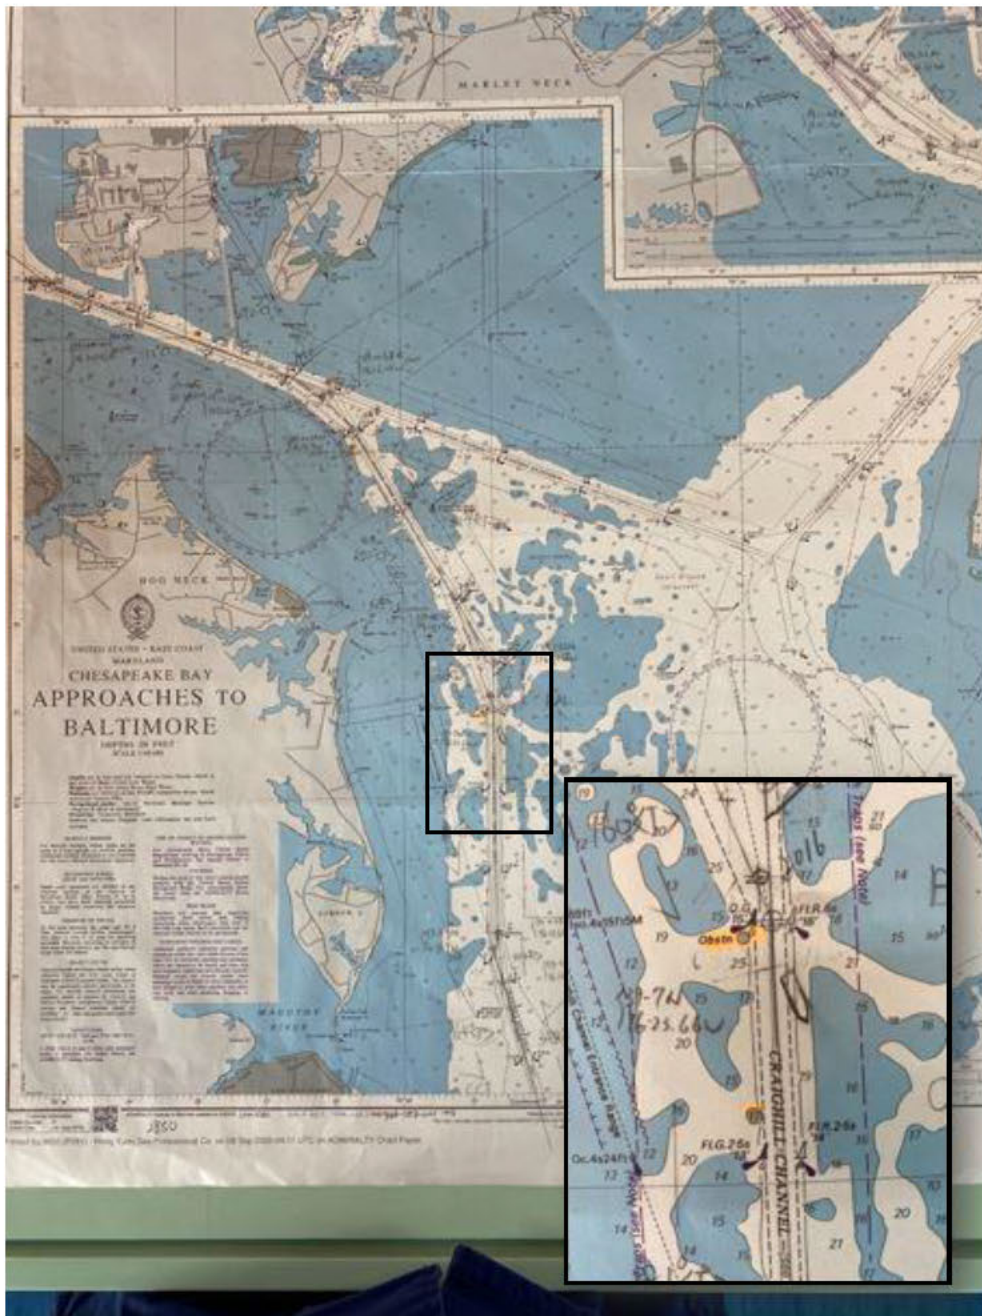
4.1.5. Pilot 1 was not aware that there were paper charts available and in use by the bridge team at the time of the transit.

Figure 3. Paper chart that was in use and on the bridge of the EVER FORWARD at the time of the grounding. The outlined inset shows a close-up of the plotted voyage plan track line and waypoints as well as the vessel location after grounding. Photograph by USCG Investigator.

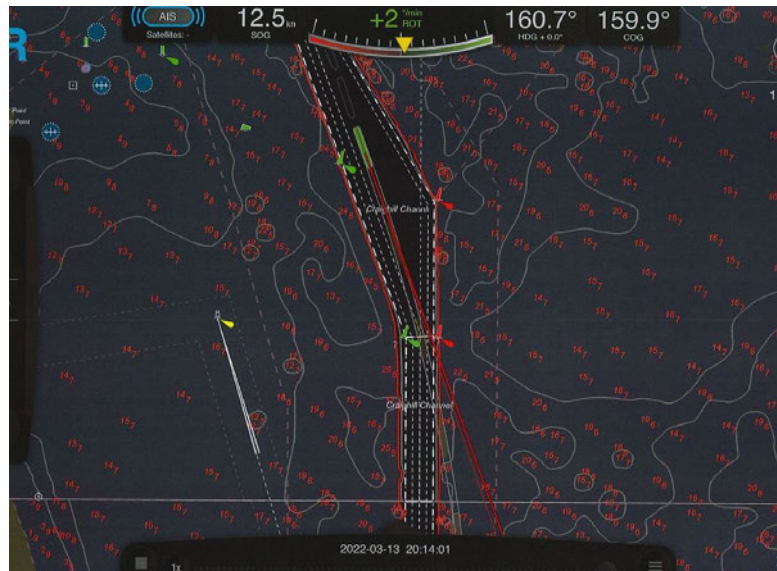
4.1.19. At 2014, Pilot 1 viewed another screen on the PPU with the intent to screenshot data from another voyage. This action stopped the recording of the active transit, and the PPU did not begin recording the active transit again until 2019, after the vessel grounded and the pilot returned to the active screen.

Figure 5. PPU screenshot just before the end of the first recording of EVER FORWARD's transit at 2014 on March 13, 2022, just prior to the grounding. Image provided by Pilot 1.

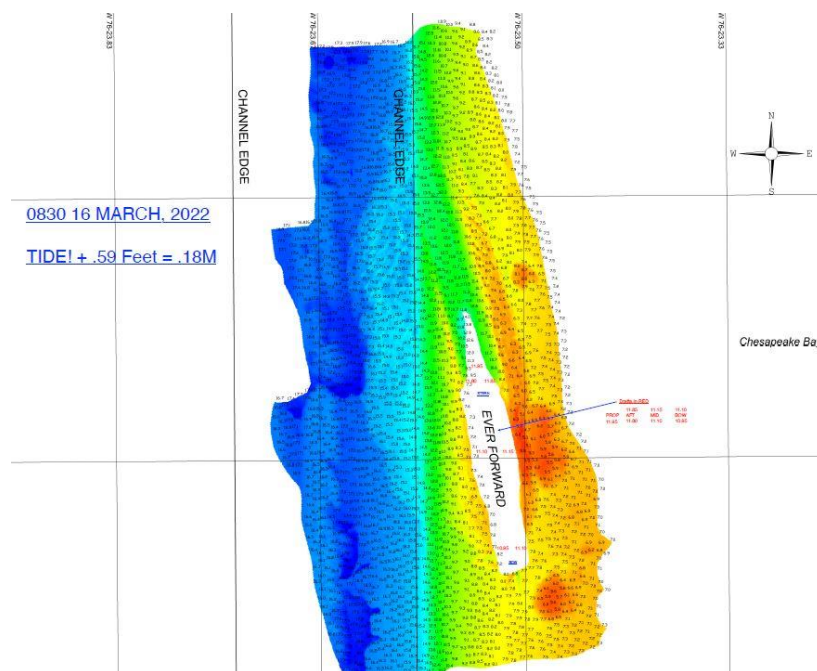
Figure 8. Multi-beam survey of EVER FORWARD grounded outside the Craighill Channel. Survey was conducted and image was produced by Donjon-SMIT LLC.

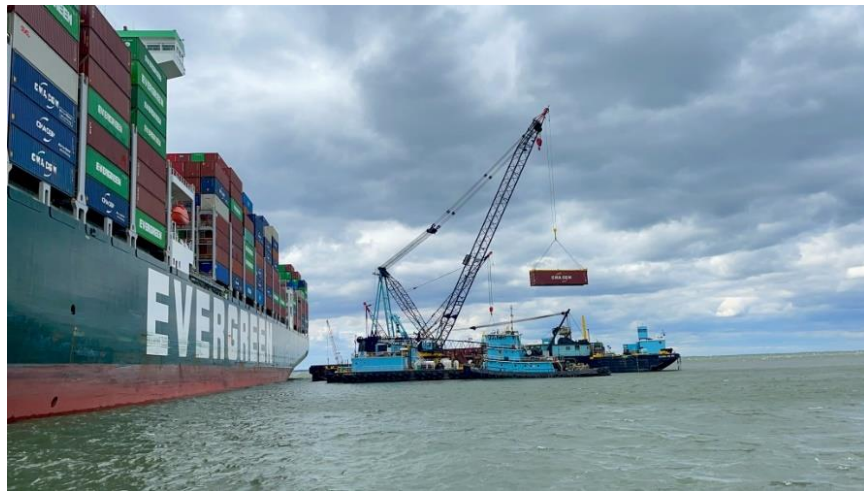
Figure 11. Crane operations on the port side of the EVER FORWARD during attempts to refloat the vessel. This photograph was provided by USCG District 5 Public Affairs.

4.2.22. On April 17, 2022 at approximately 0700, the EVER FORWARD was successfully pulled back into the channel and refloated, after dredging 206,280 cubic yards of material and the removal of 505 containers.

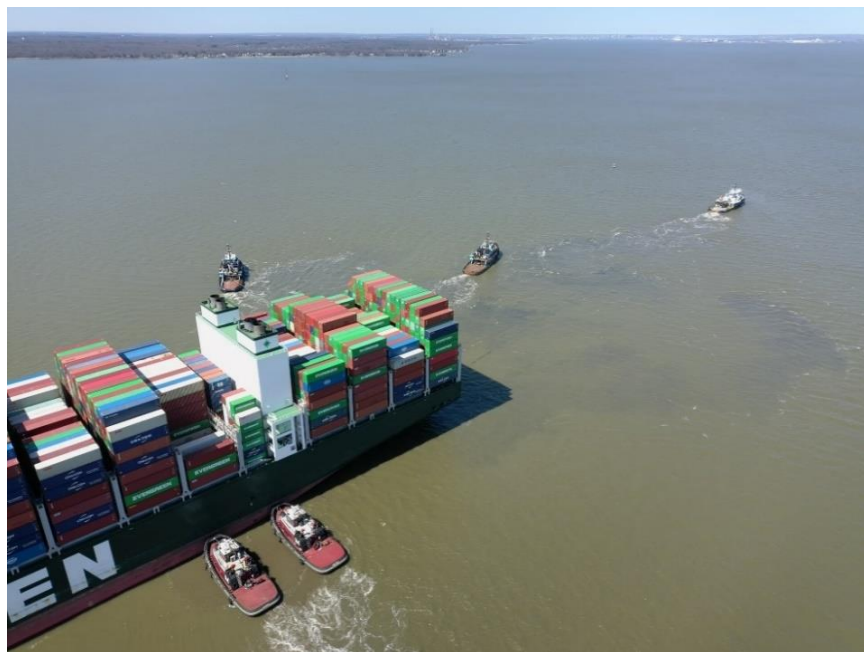
Figure 12. Aerial photo of the EVER FORWARD aft port quarter during refloat operations in an attempt to free the vessel. This photograph was provided by USCG District 5 Public Affairs.
