Hampton Roads District

Guardrail Hits Evaluations

Updated October 2018

In the Spring of 2017, as part of VDOT's focus to improve guardrail safety, Central Office Traffic Engineering analyzed statewide crash data and developed lists of the most frequently hit guardrail terminals in the Commonwealth and each District. The District Traffic Engineers were asked to investigate the top sites in their jurisdictions and develop plans for site modifications which could reduce the frequency of guardrail terminal crashes.

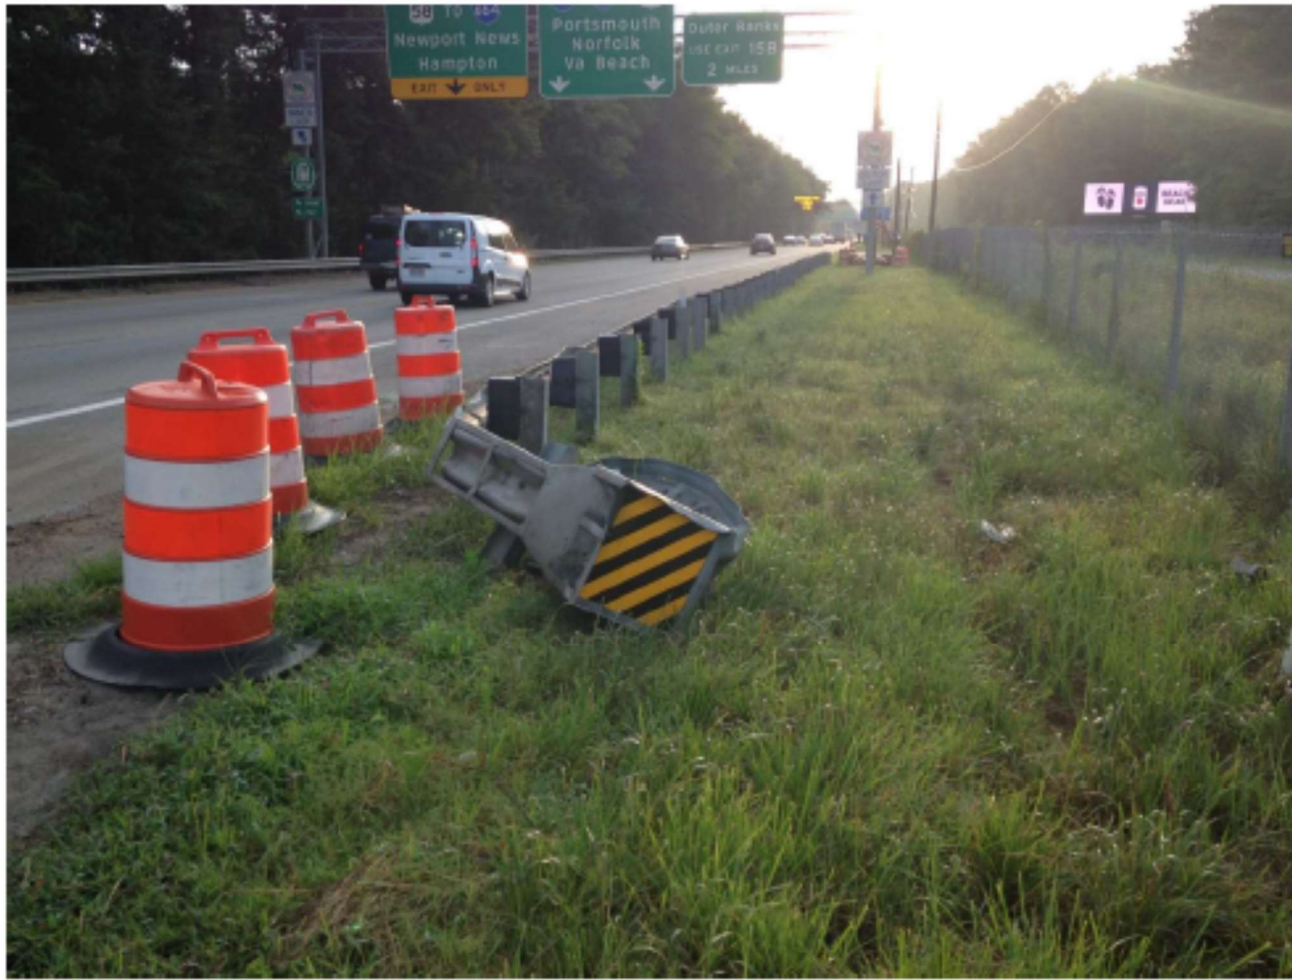
Before Photo #1

- The previous guardrail run consist of a SKT-SP GR-9 Run-on End Terminal attached to Standard GR-2 W-Beam rail with a Rolled Buffered End Treatment. The previous overall length of the guardrail run was approx. 250' located at an offset of 12' from the edge of travel and 2' from the Edge of the paved shoulder.
- The guardrail is protecting an overhead sign structure that is located approx. 20' from the Edge of Travel to the back of the structure and approx. 215' from the center of the intersection of Snowden Road. The previous length of guardrail from the run-on end terminal to the sign structure is approx. 165'.
- The current calculated length of need is 144'.
- The existing cross slope of the shoulder is relatively flat approx. 6:1.
- The Current ADT is approx. 74,000 with 6% truck traffic.

- Review of Crash Data and discussions with the HITS contract manager responsible for repairing this guardrail indicate that most of the damage incidents are the result of trucks making U-turns from South Military Highway onto EB Route 58.

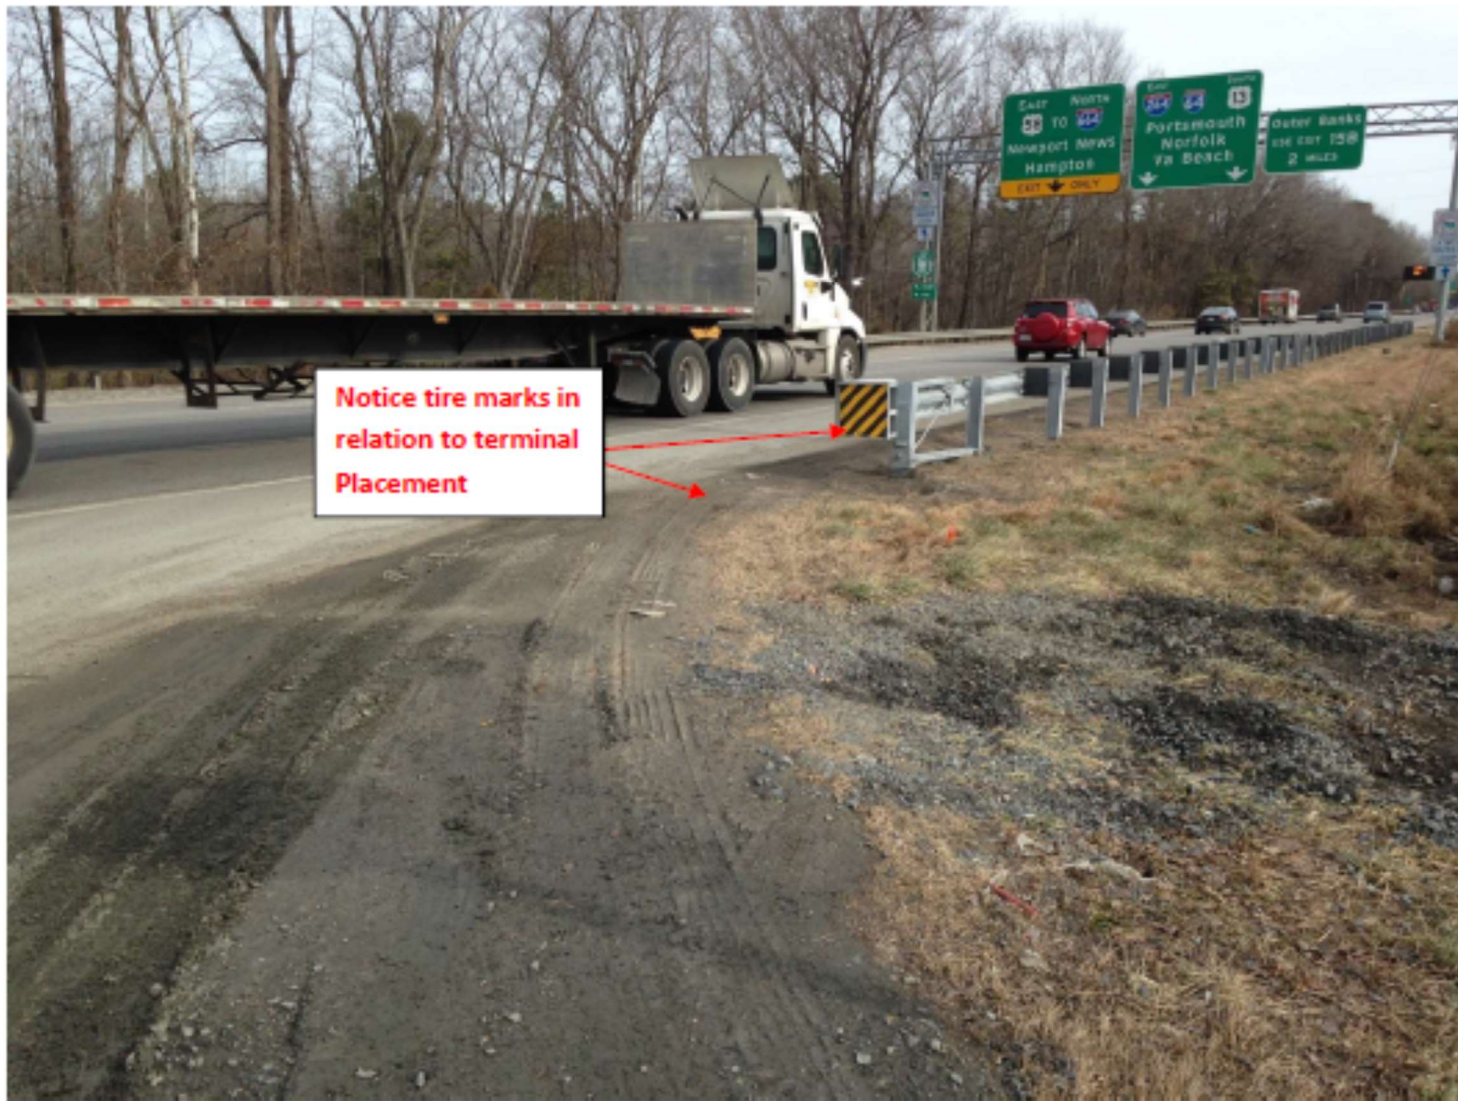
After Photo #2 (First Repair terminal not moved back 12.5')

- Replacement efforts at this site were hampered by limitations of the HITS contract and the time to modify that contract to include MASH standards.
- Since the June 2017 investigation, this terminal has been replaced and struck three times. As shown in the photo above labeled "After Photo #2" the first repair the terminal was installed utilizing current MASH Standards but was not moved back 12.5' as recommended, also shown in "After Photo #3" the latest repair of the terminal was again not installed per recommendations and shortened 12.5'.

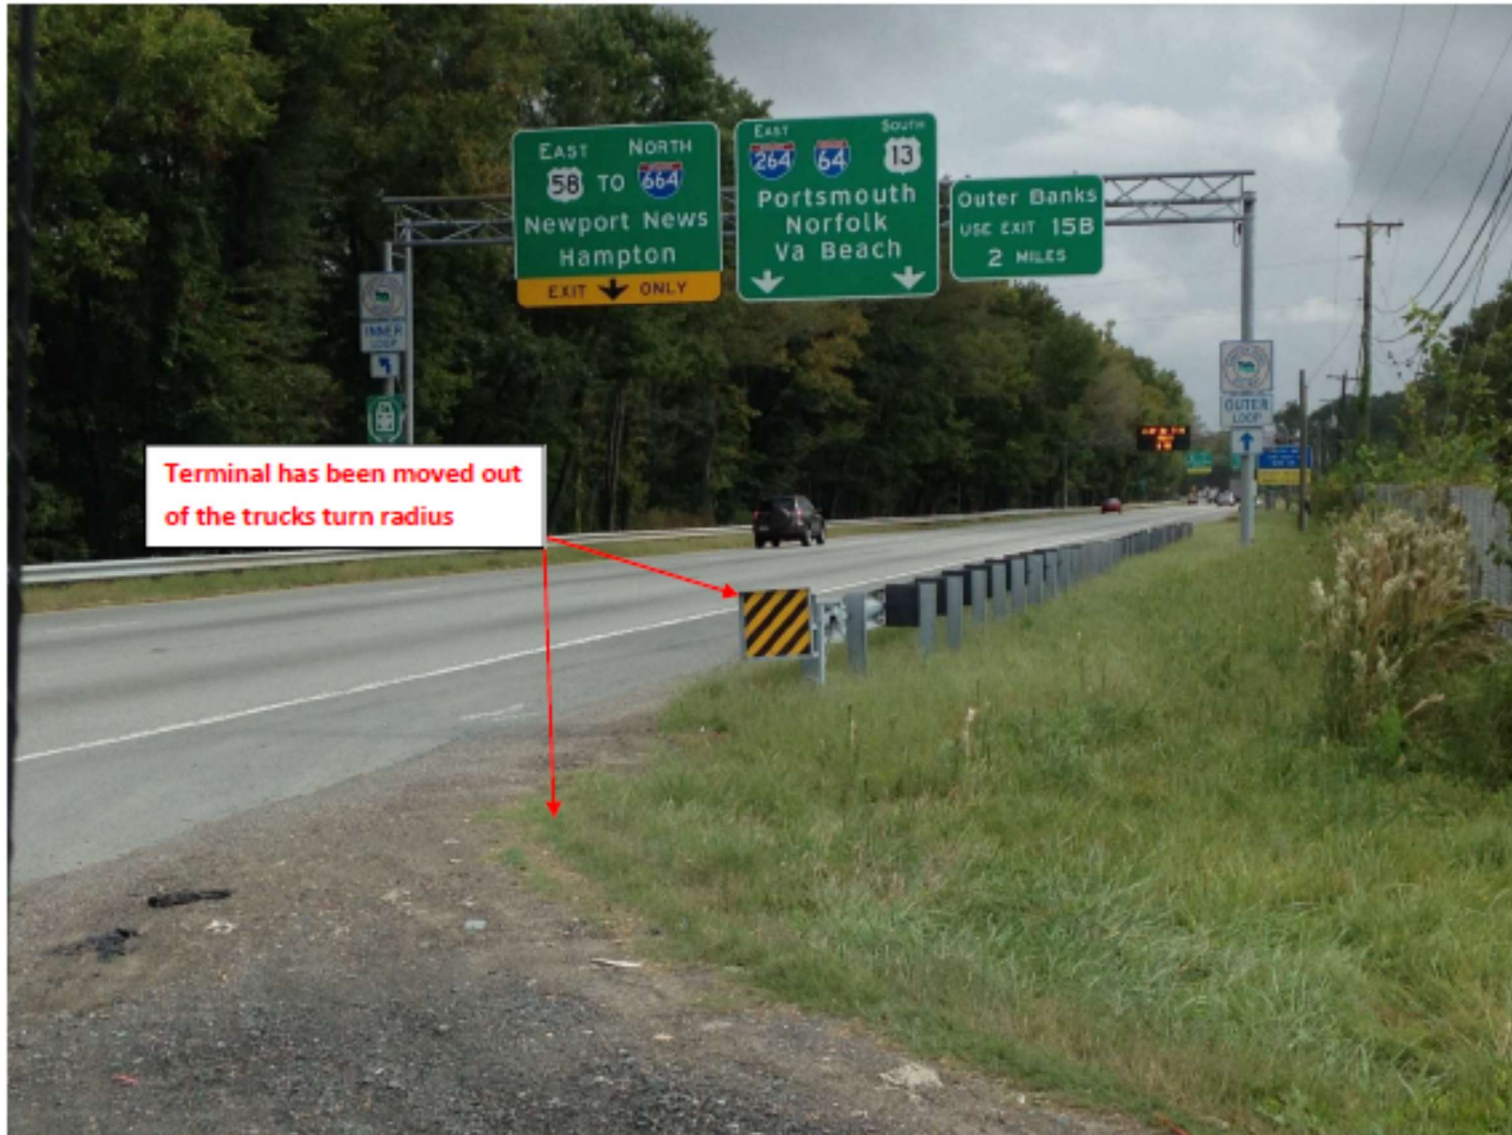
Solution Photo

- As shown in the previous photo the Terminal was replaced in August of 2018 and moved back 12.5' as recommended in the attached sketch, this has resolved the issue of truck traffic side swiping the terminal head.

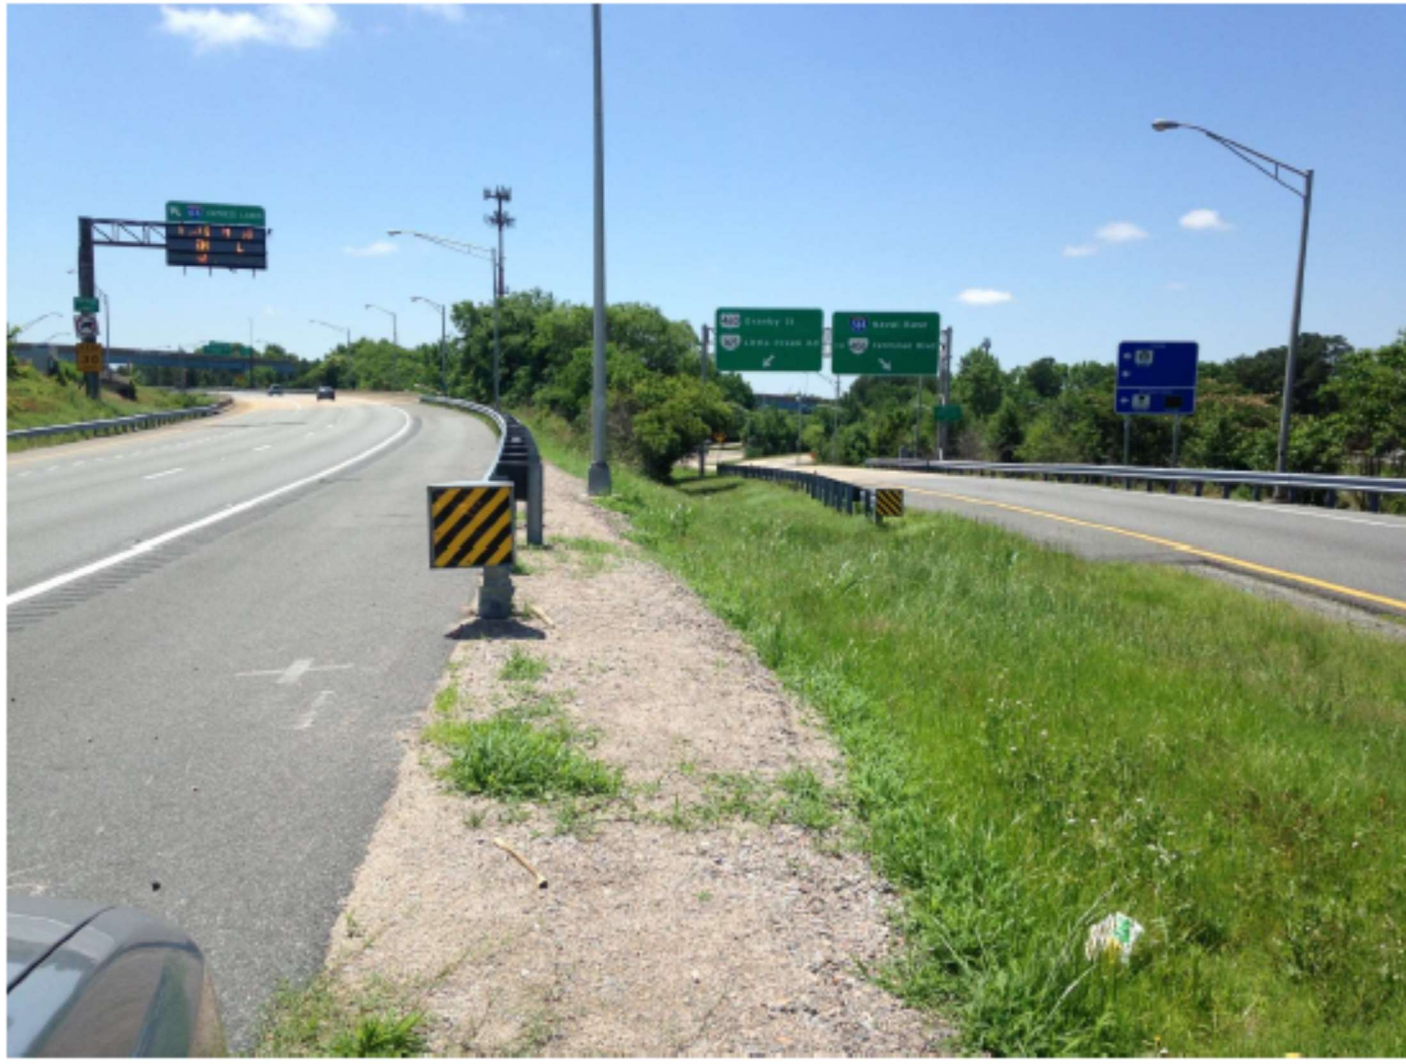
Top 6 Hampton Roads Guardrail Hits Evaluations
Site #2
After Photo

- Traffic Engineering requested a rumble strip installation task order for this site and Sites 4 and 5. Installation and Maintenance reported that these sites did not include a sufficient length of rumble strip to meet the minimum length required to initiate a task order under the FY17 pavement marking on-call contract.
- This site was hit in early March 2018. (The Task Order was received by the HITS Coordinators on March 5.) The ACE for the HITS program directed the contractor to shorten the guardrail and install the new terminal at the location indicated in the Site Sketch as recommended by Traffic Engineering. The repair has been completed as per the attached sketch, (see photo).

- Shorten Guardrail by 25' and replace existing GR-9 with New MASH Standard End Terminal (GR-MGS-2). This would still maintain the length of need required for the non-recoverable slope break.
